Site Inspection – 04/01/2022

Re: Hazardous Materials Inspection Services for the Sherwood Recreation Center Located at 920 N. Main Street in Salinas, California.  
M<sup>3</sup> Project No. 23581.0 Task 1

The proposed rehabilitation project involves removal of existing deteriorated wood shingle exterior siding covering the older wall surfaces throughout the facility and replacing it with a new siding material such as metal, stucco, and/or cement board finish; testing, remediation, and/or removal of lead-based paint and asbestos containing materials on the inside or outside of the facility; removal of the existing single-ply TPO or PVC roof membrane and installation of new one; removal of existing plywood roof covers and installation of new roof skylights and/or installation of roof coves to allow the natural venting of the facility; removal of existing gutters and downspouts and installation of new ones; removal of abandoned stairs, associated roof, and a column at the northeast corner of the facility; slurry seal of the parking area on the west side of the building including restriping of parking spaces to conform with the American with Disabilities Act (ADA); removal of existin

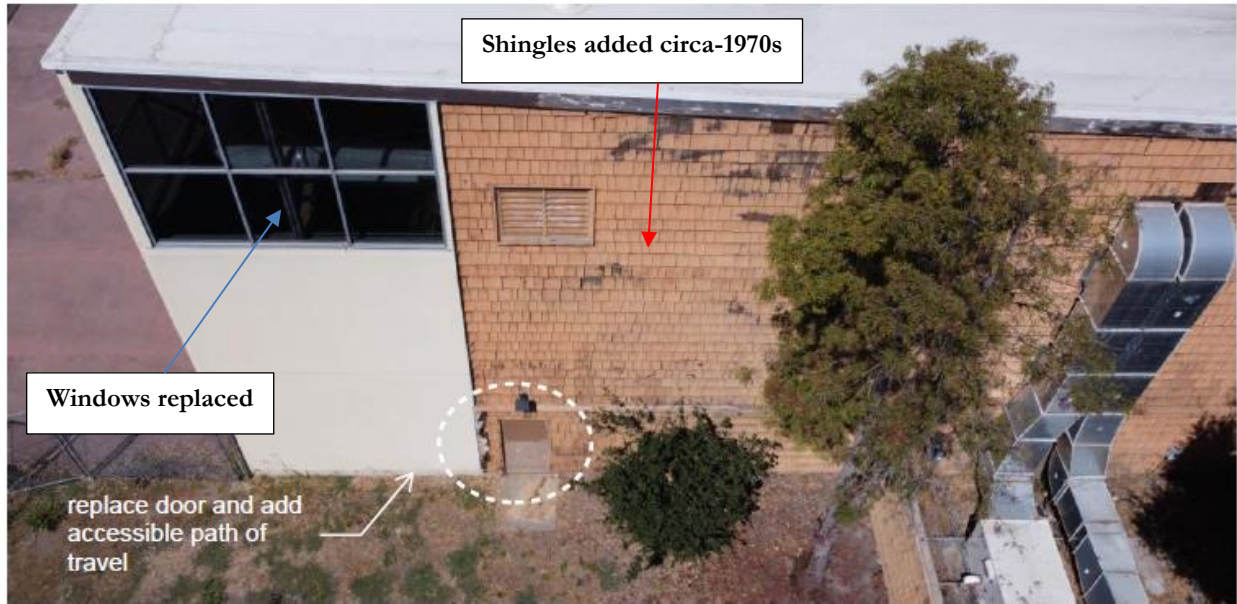
1. East Facade showing deteriorated wood shingles, Scope item SR2, SR9

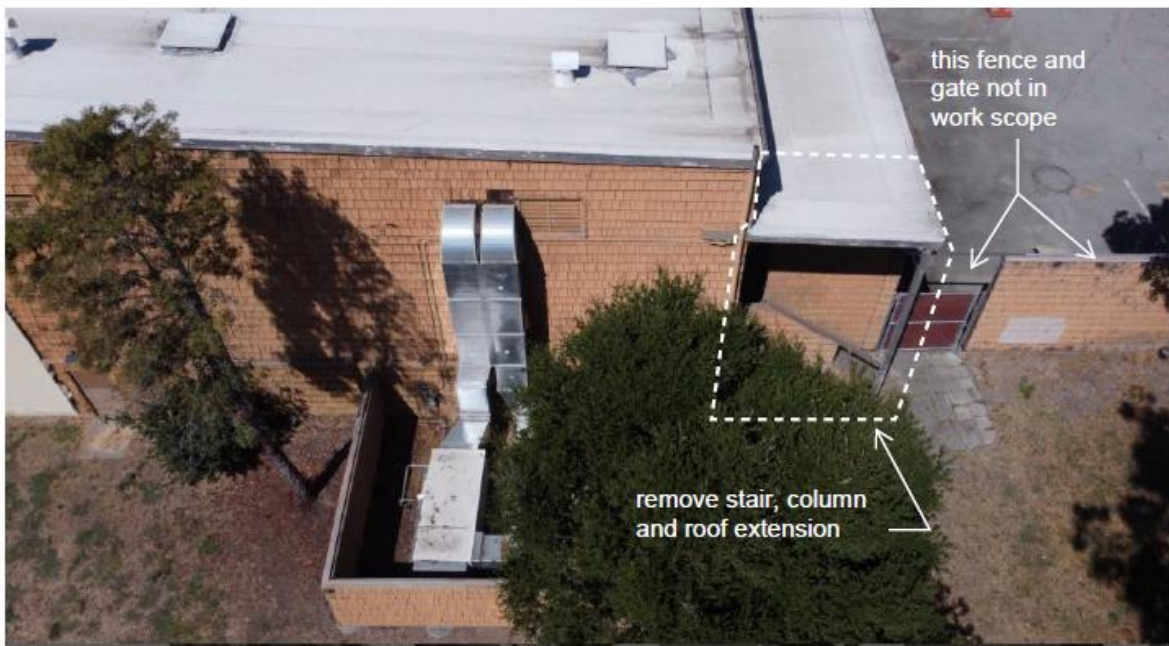
**Figure 4: East façade proposed scope of work.**

2. East Facade showing deteriorated wood shingles, Scope items SR1, SR2

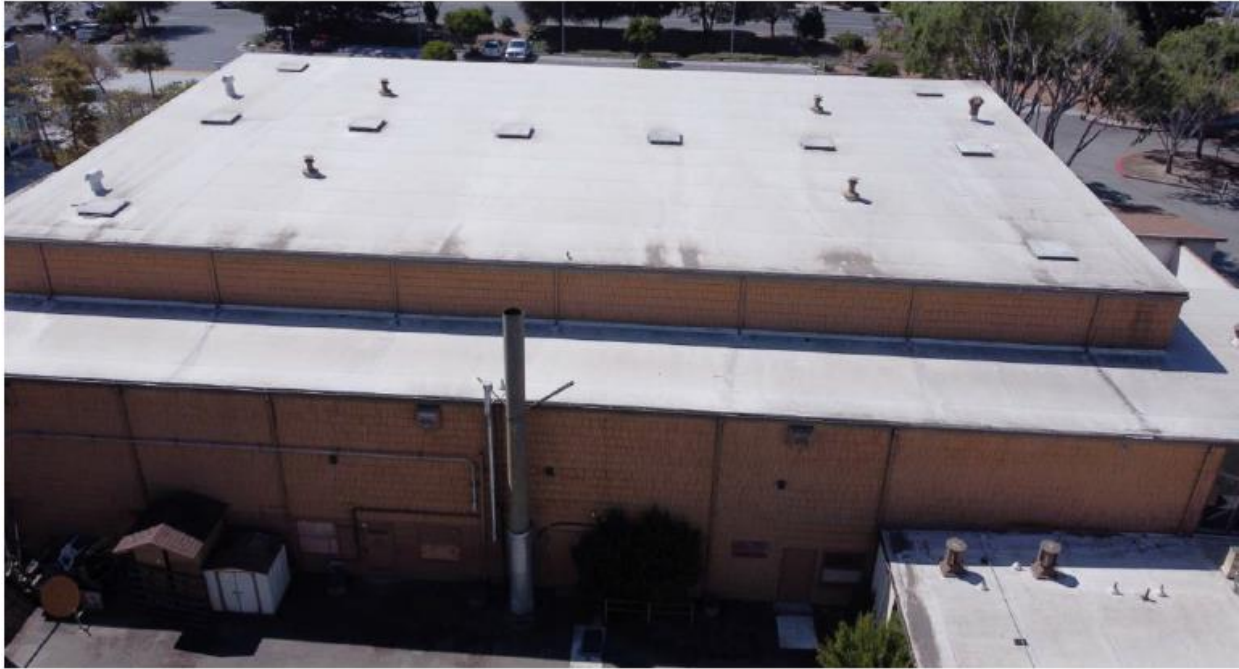
**Figure 6: North façade scope of work.**

4. North facade; windows to be replaced, old boiler flue to be removed, service yard repaved and graded  
scope items SR6, SR12

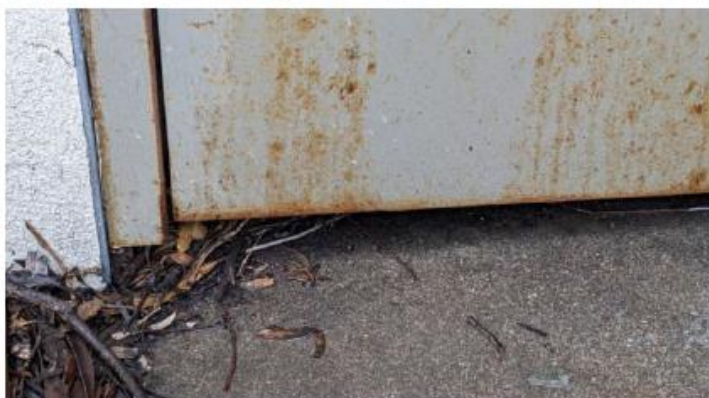
Figure 10: Foundation/slab southwest corner scope of work.

8. foundation/slab settlement at SW corner of building: scope item SR7

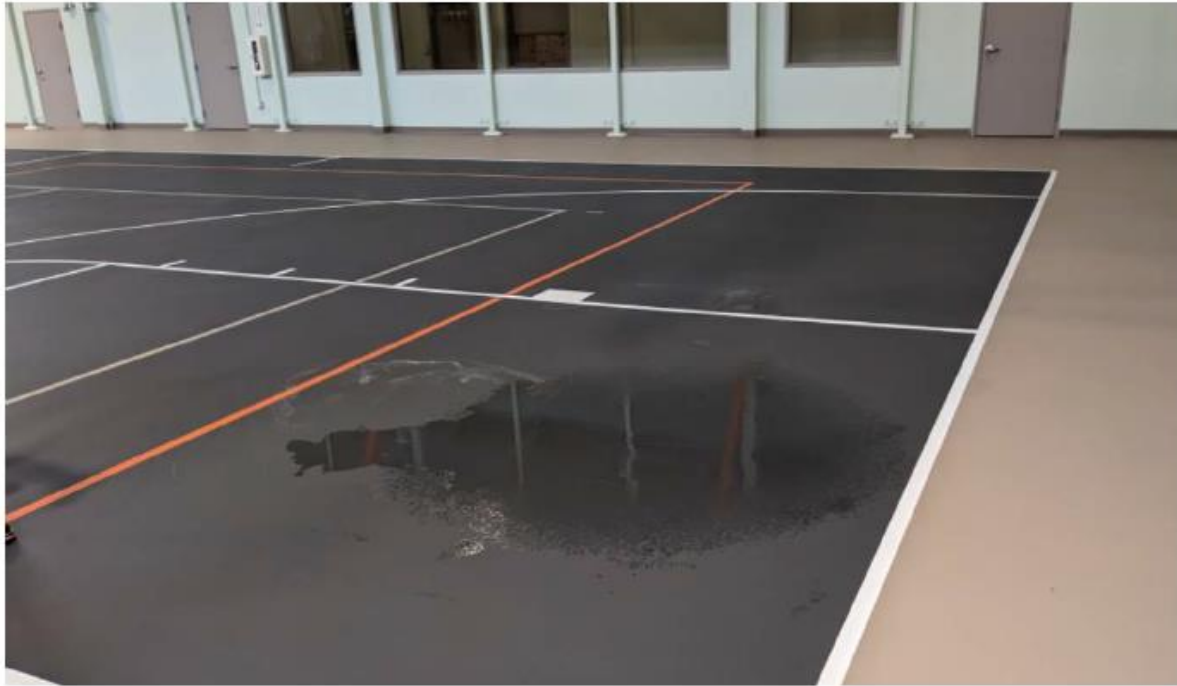
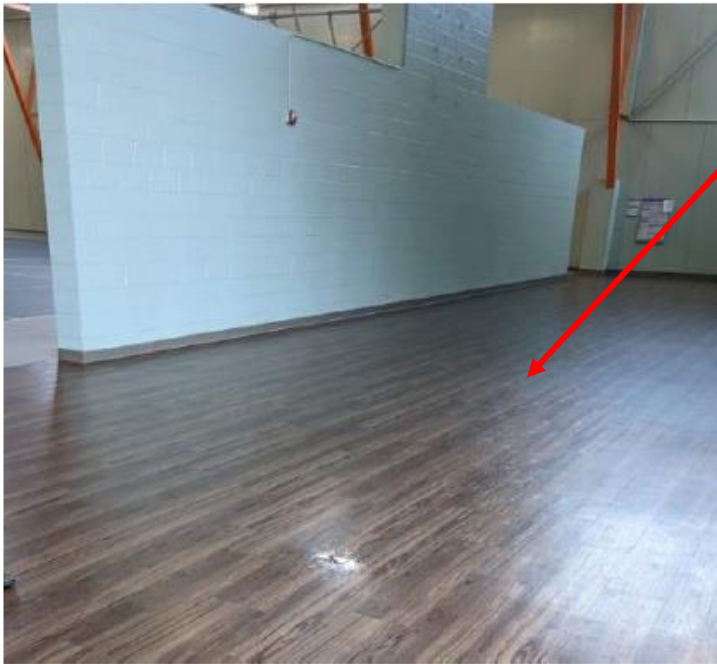
Figure 11: Interior recreation center scope of work.

9. Water intrusion at existing skylight patches

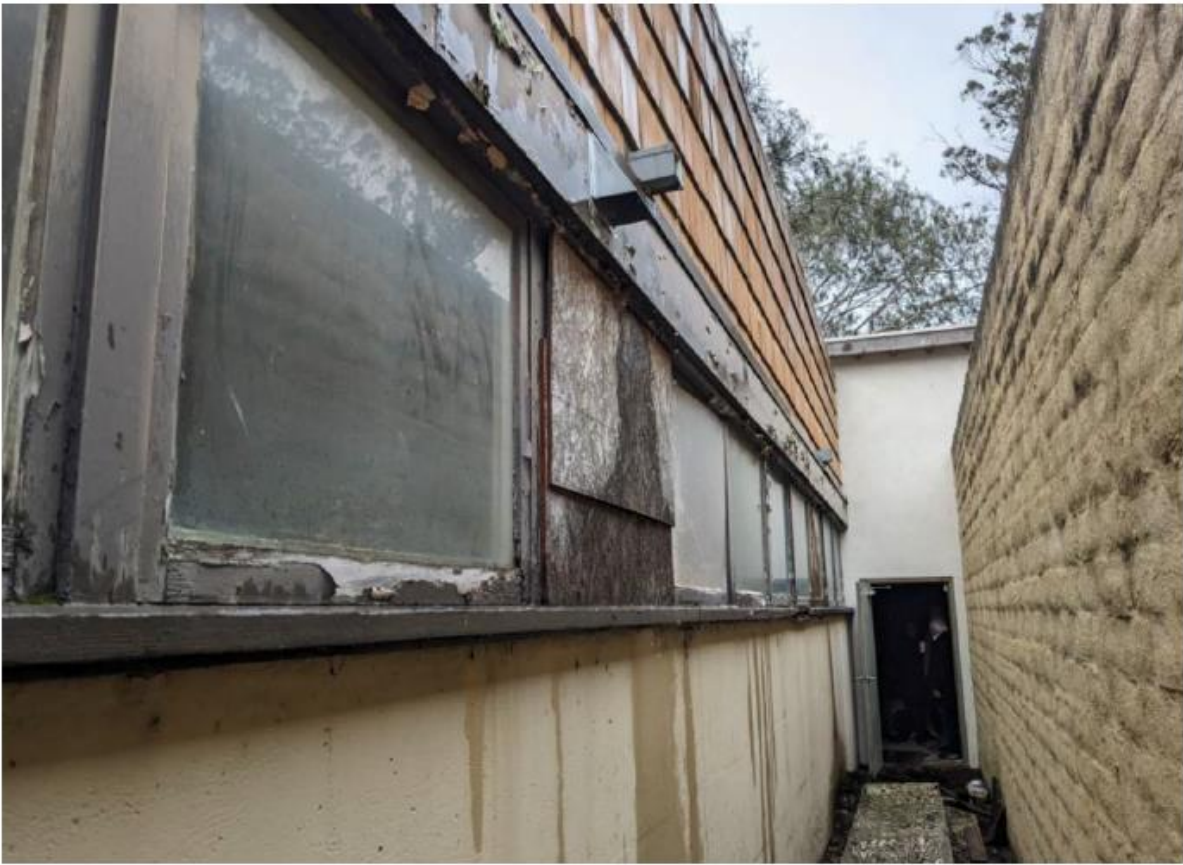
**Figure 12: Deteriorated windows and scope of work.**

10. Deteriorated windows, exposed roof scuppers with no rainwater leaders, existing CMU screen wall to be removed; scope items SR5, SR6, SR19

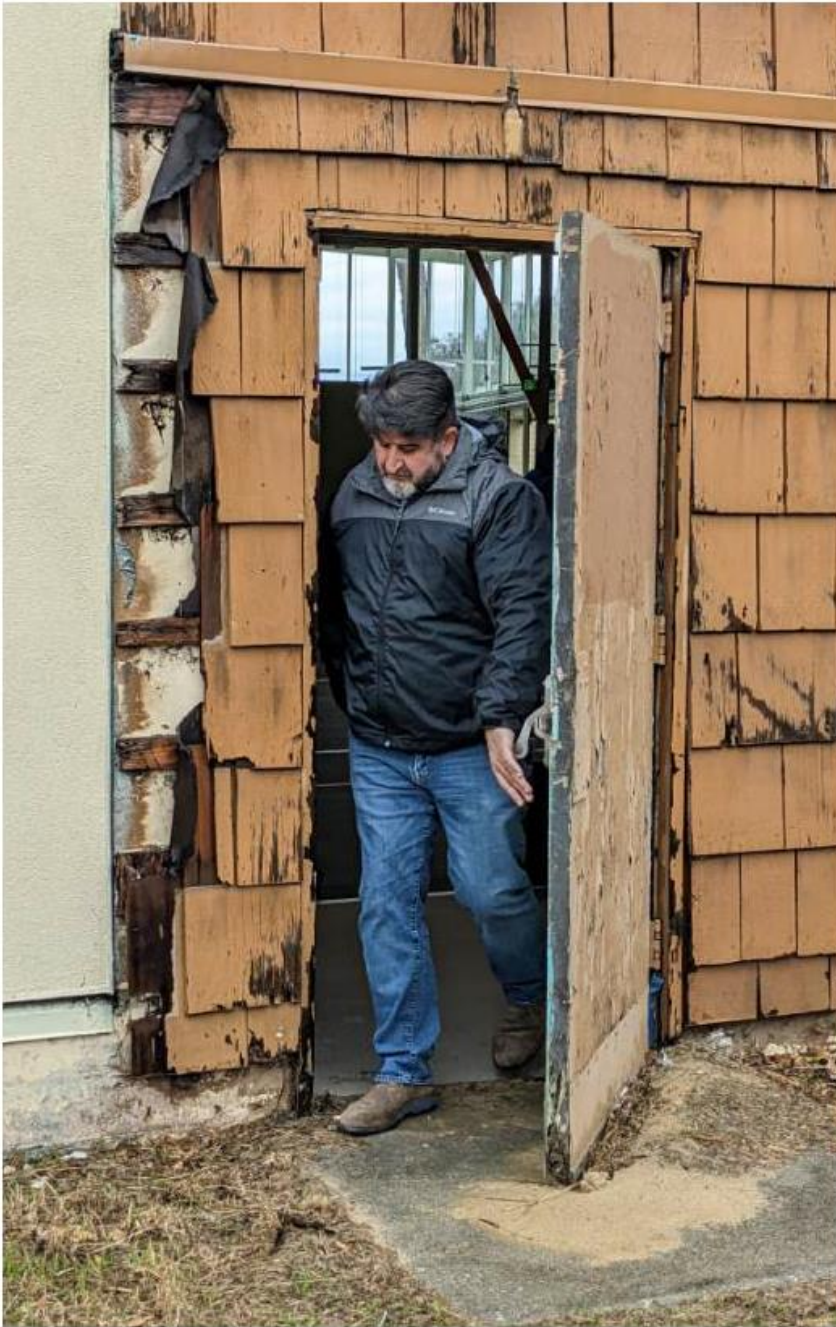
**Figure 13: Deteriorated shingles and scope of work.**

11. Deteriorated shingles and egress door at east side of building; scope item SR9.

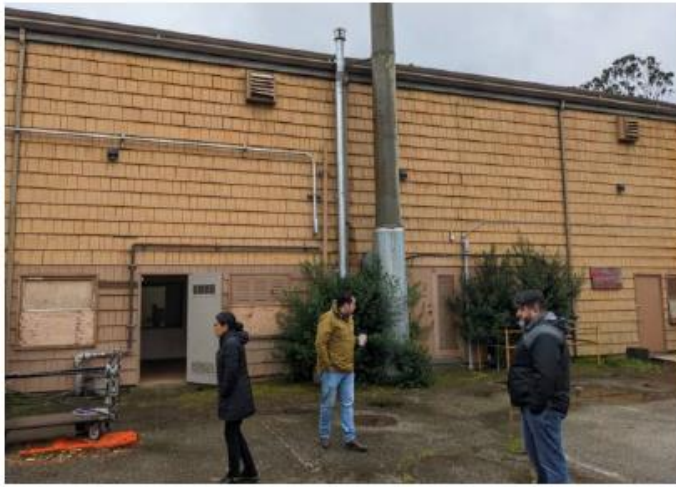
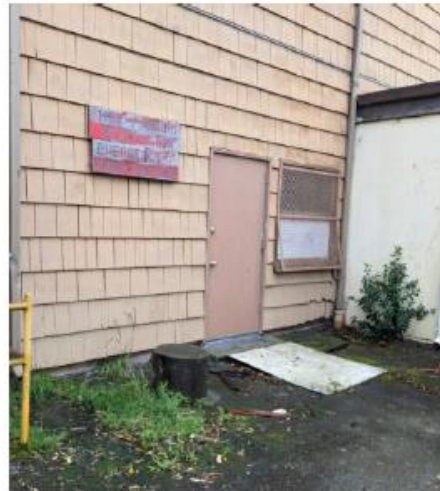
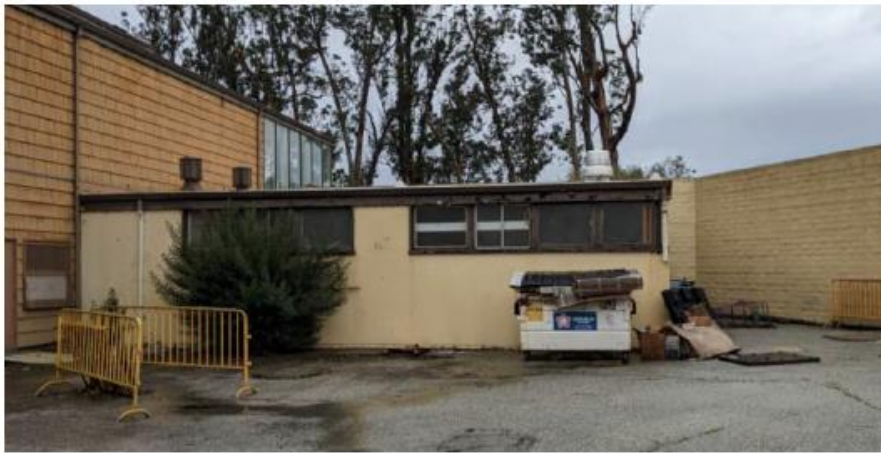
**Figure 14: North service yard scope of work**

12. North service yard showing windows to be replaced and non-compliant entry doors. scope items SR6, SR12.

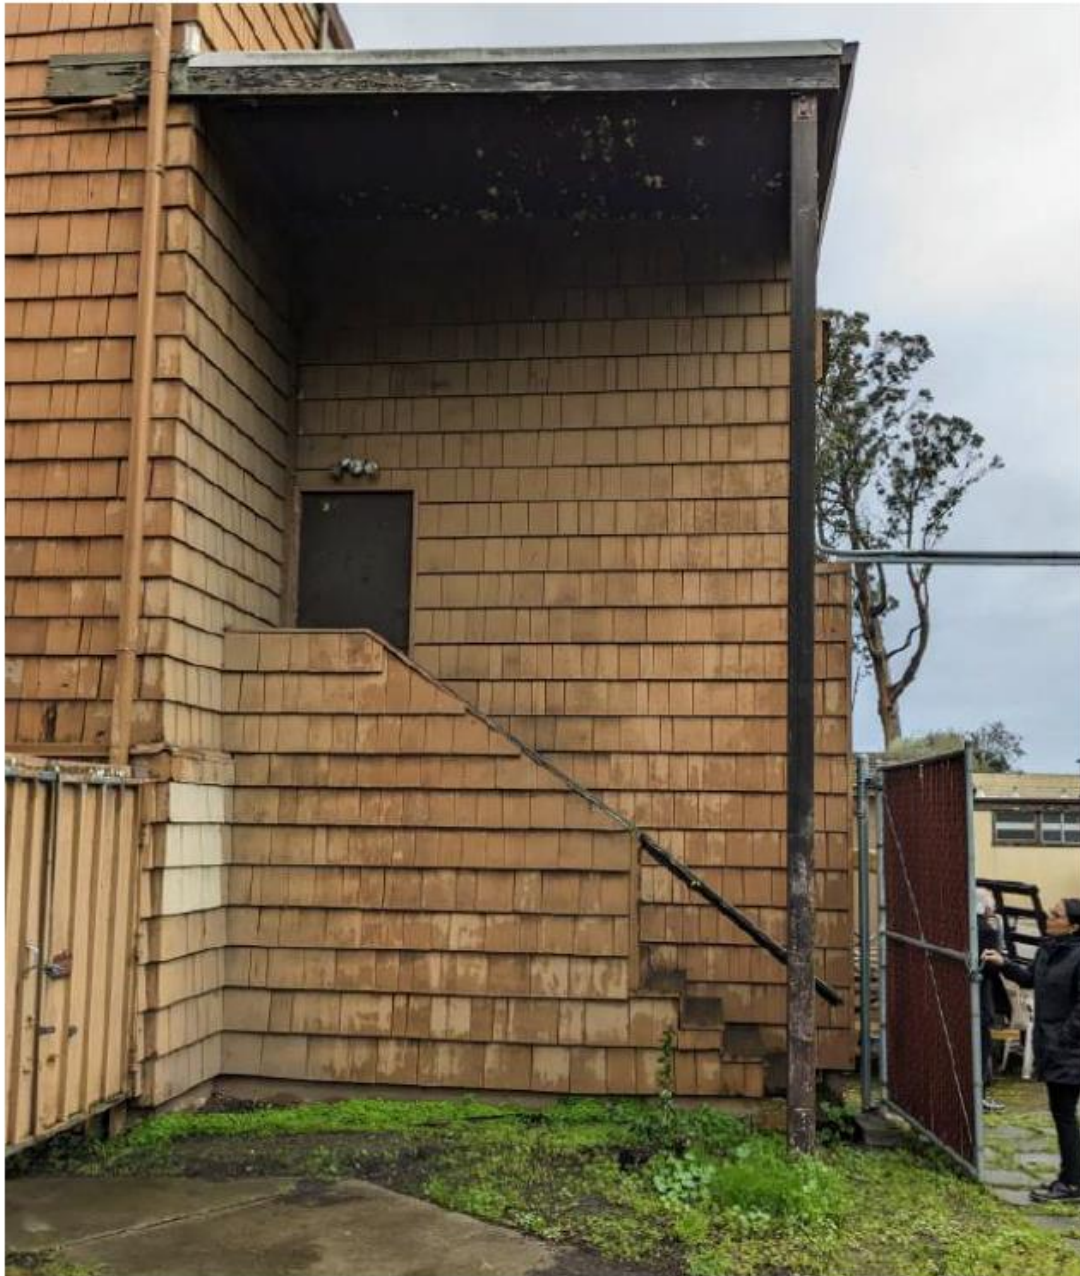
Figure 15: Northeast corner scope of work.

Figure 15: NE corner of building showing abandoned stair, column, door, and roof to be removed
