# FLOOD INSURANCE STUDY

**CITY OF SALINAS,  
CALIFORNIA  
MONTEREY COUNTY**

**MAY 4, 1981**

**COMMUNITY NUMBER - 060202**

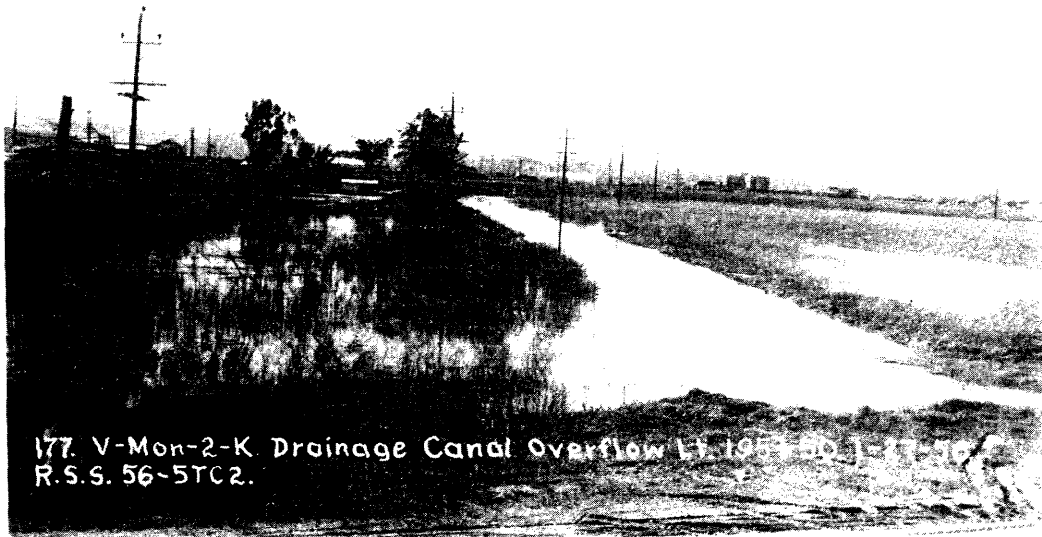
Figure 2. Reclamation Ditch Flooding, Downstream of East Main Street, January 27, 1956

Figures 2, 3, and 4 show historic flooding in Salinas.

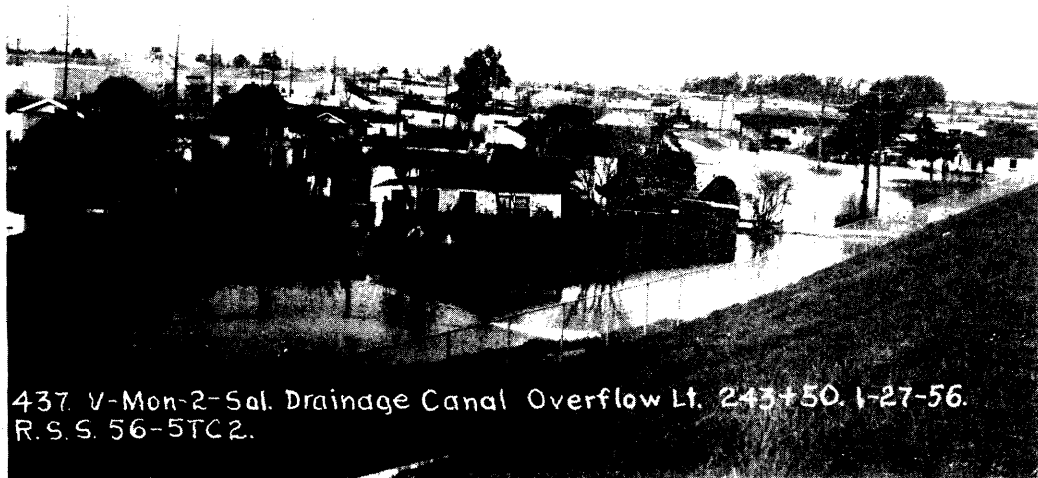
Figure 3. Reclamation Ditch Flooding, Upstream of Carr Lake Near U.S. Highway 101, January 27, 1956

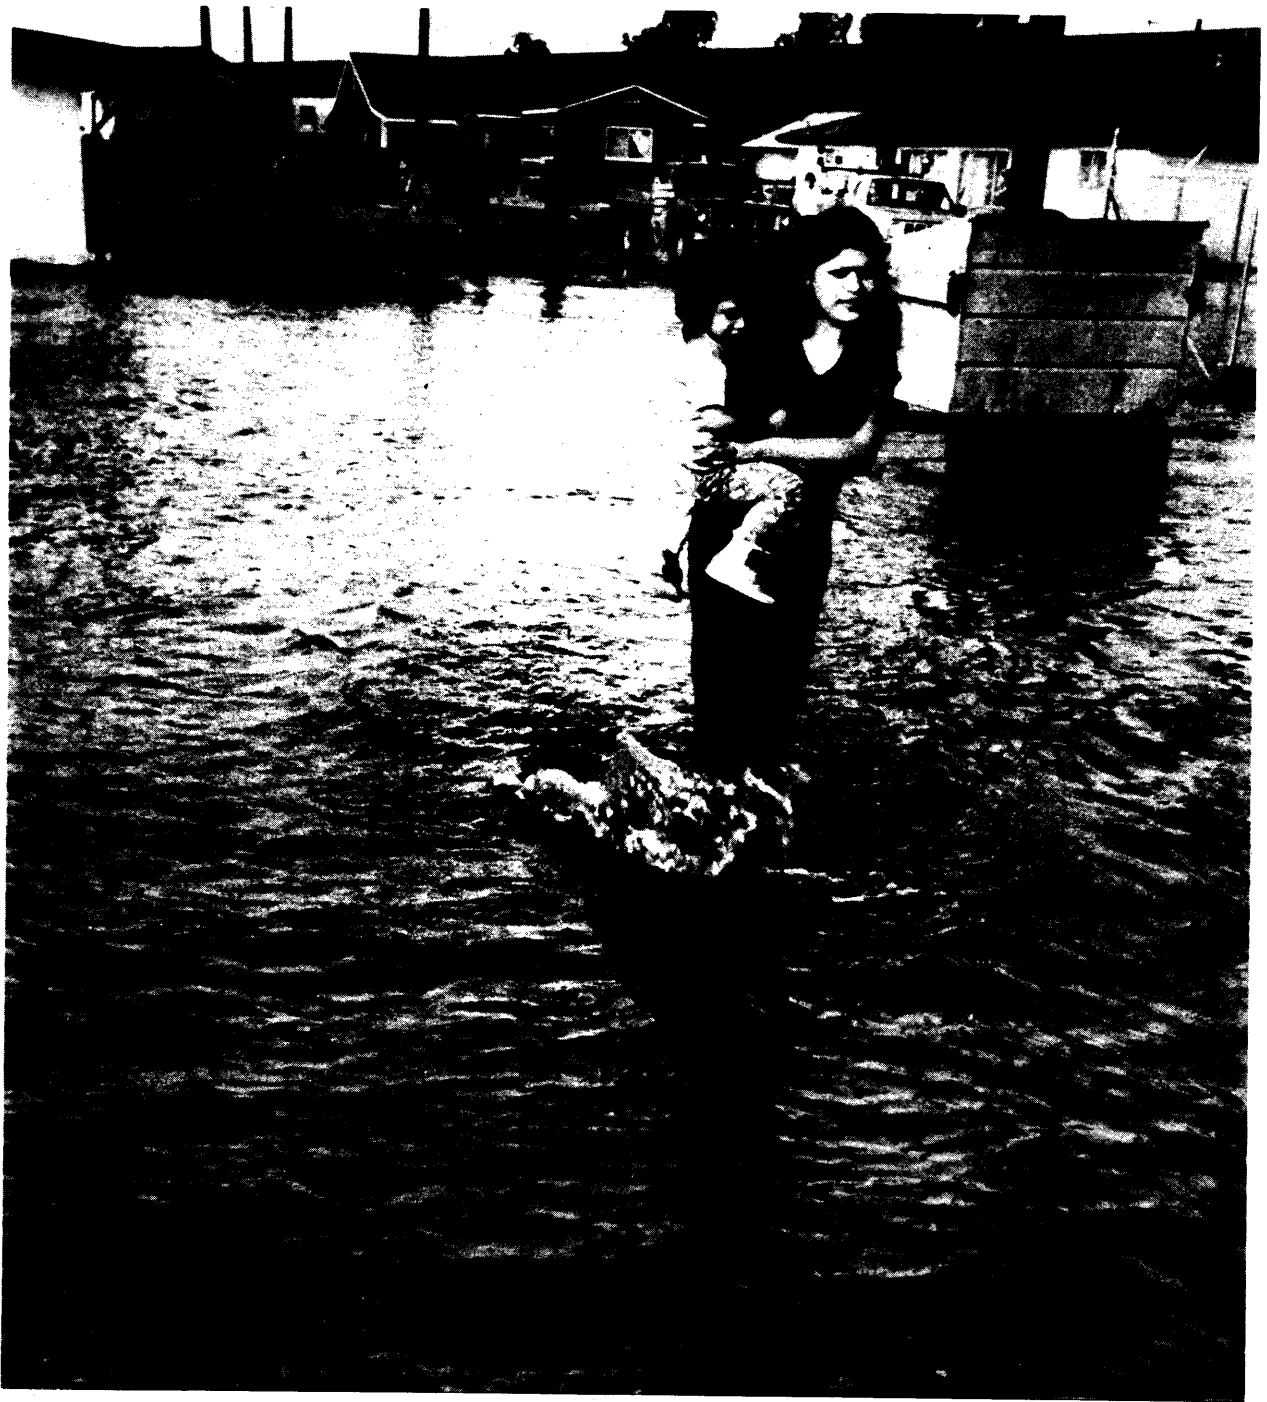
Figure 4. City of Salinas Flooding, 1973
